FIELD INVESTIGATION REPORT

Site Name: 9524 and 9540 Niagara Falls Boulevard, Niagara Falls, Niagara County

Date(s) of Visit: October 2 - 4, 2006

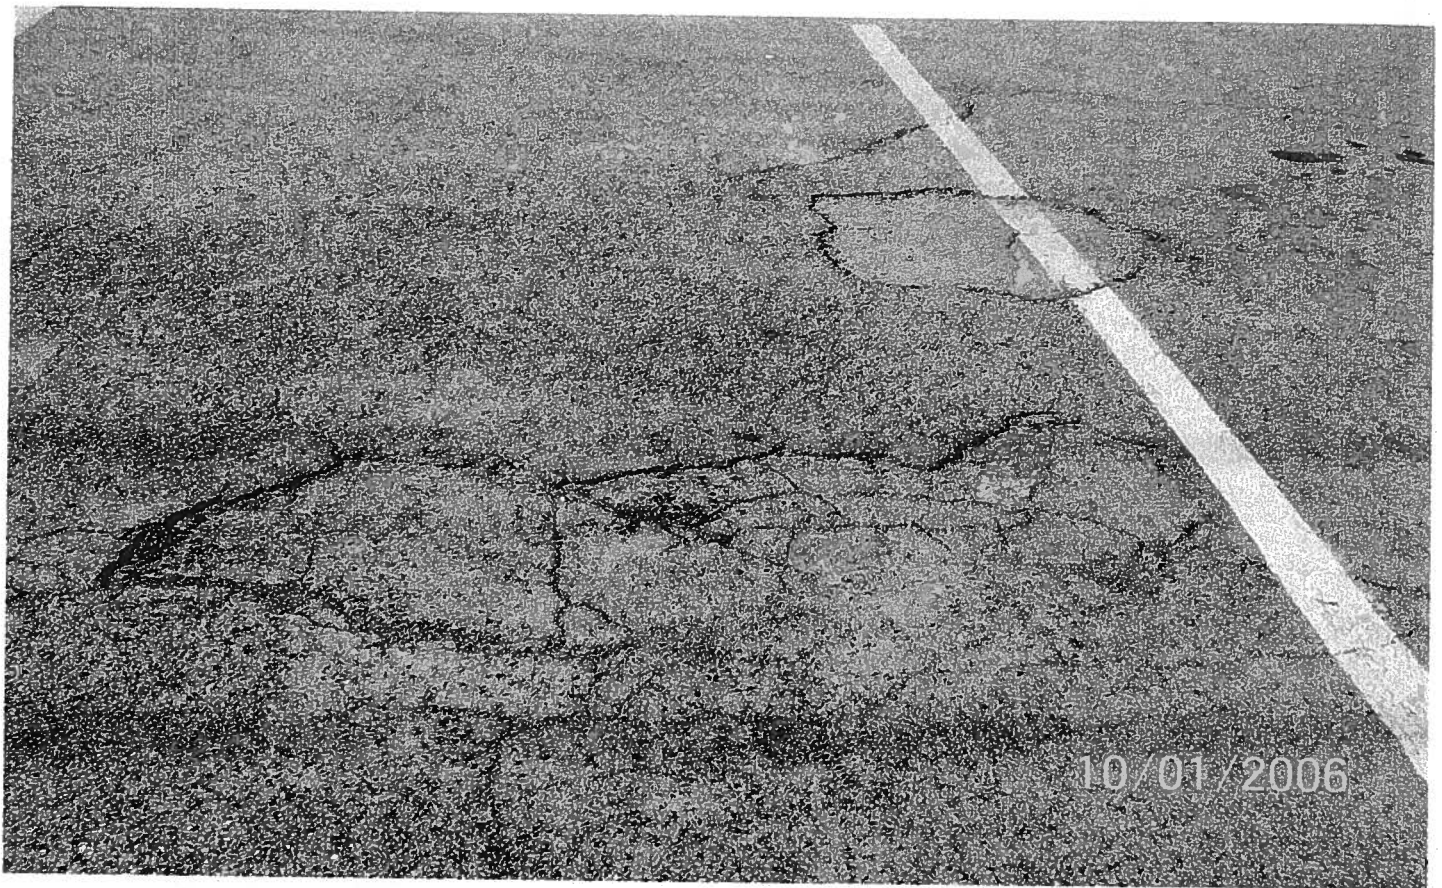
Area of Rapid Bowl parking lot showing disrepair. Note the underlying layer of asphalt. Typically these areas exhibit higher contact readings than the surrounding top layer of asphalt.

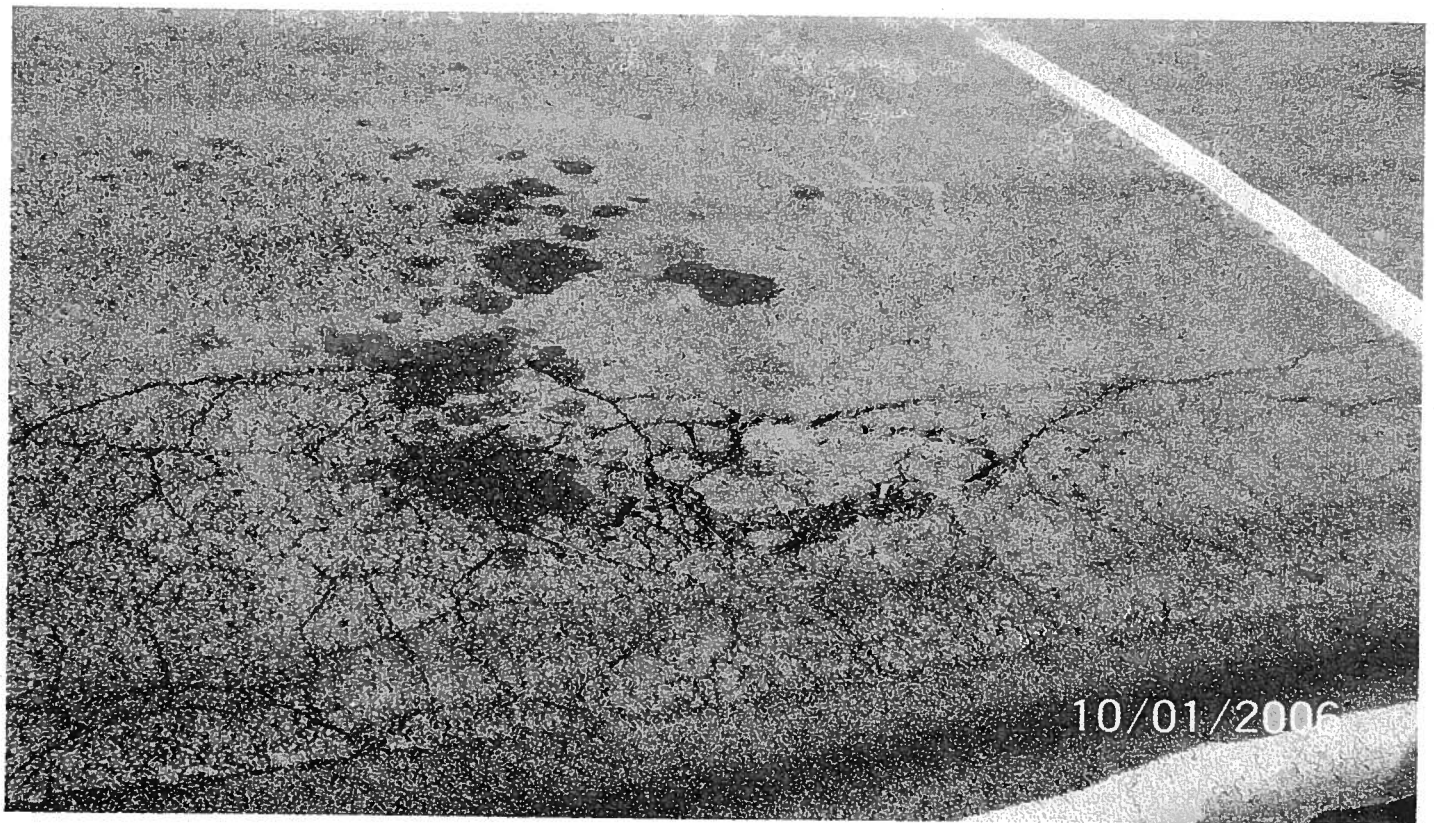
Another area of disrepair in the front parking lot of Rapid Bowl.

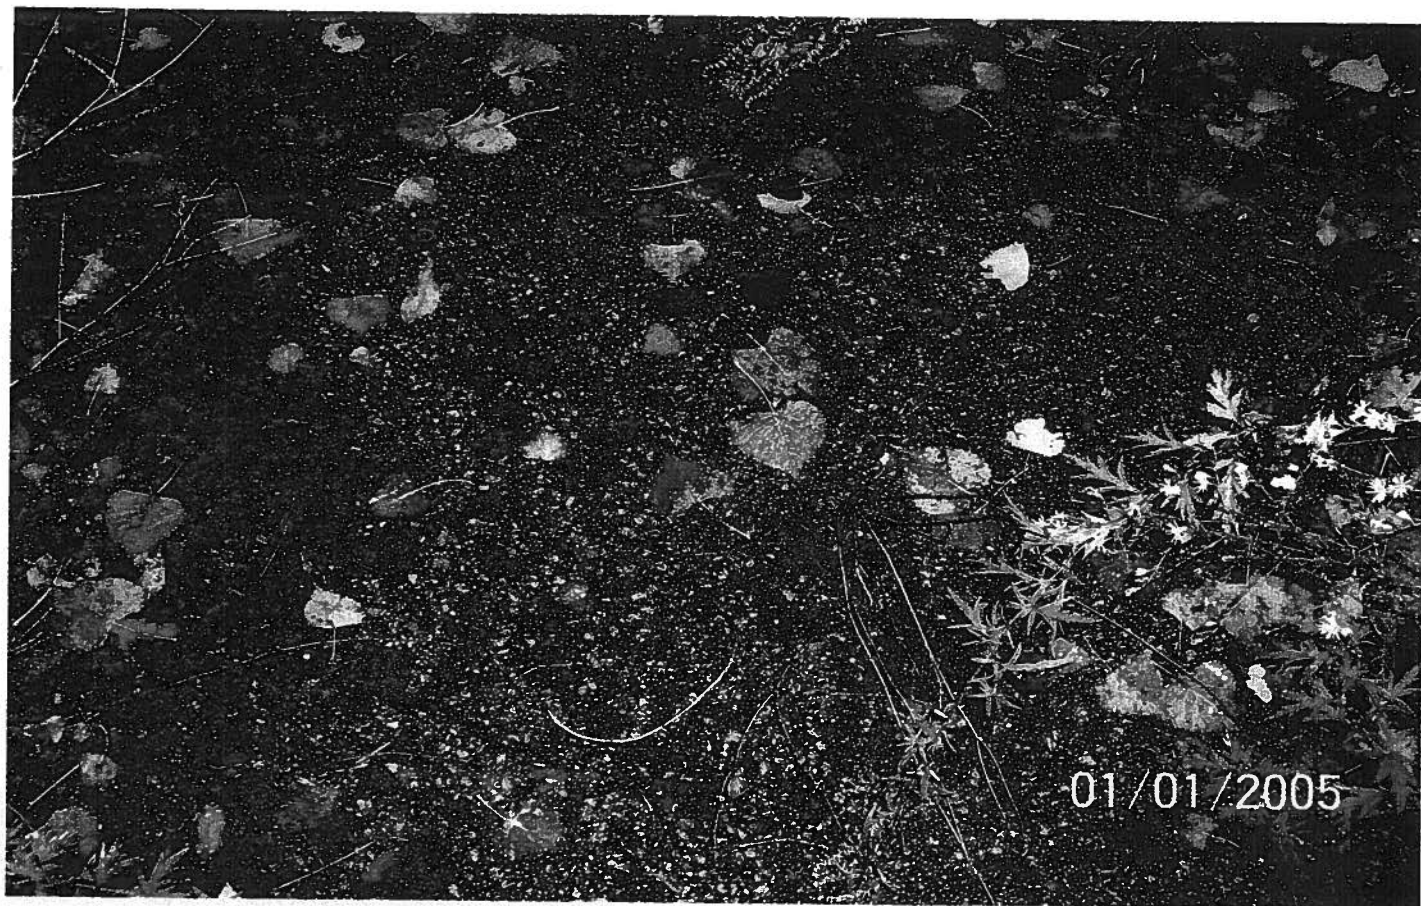
Asphalt surface in the fenced area. Note the exposed aggregate in the well-worn surface. Exposed slag is not evident here although the highest dose rate readings on site were found here.

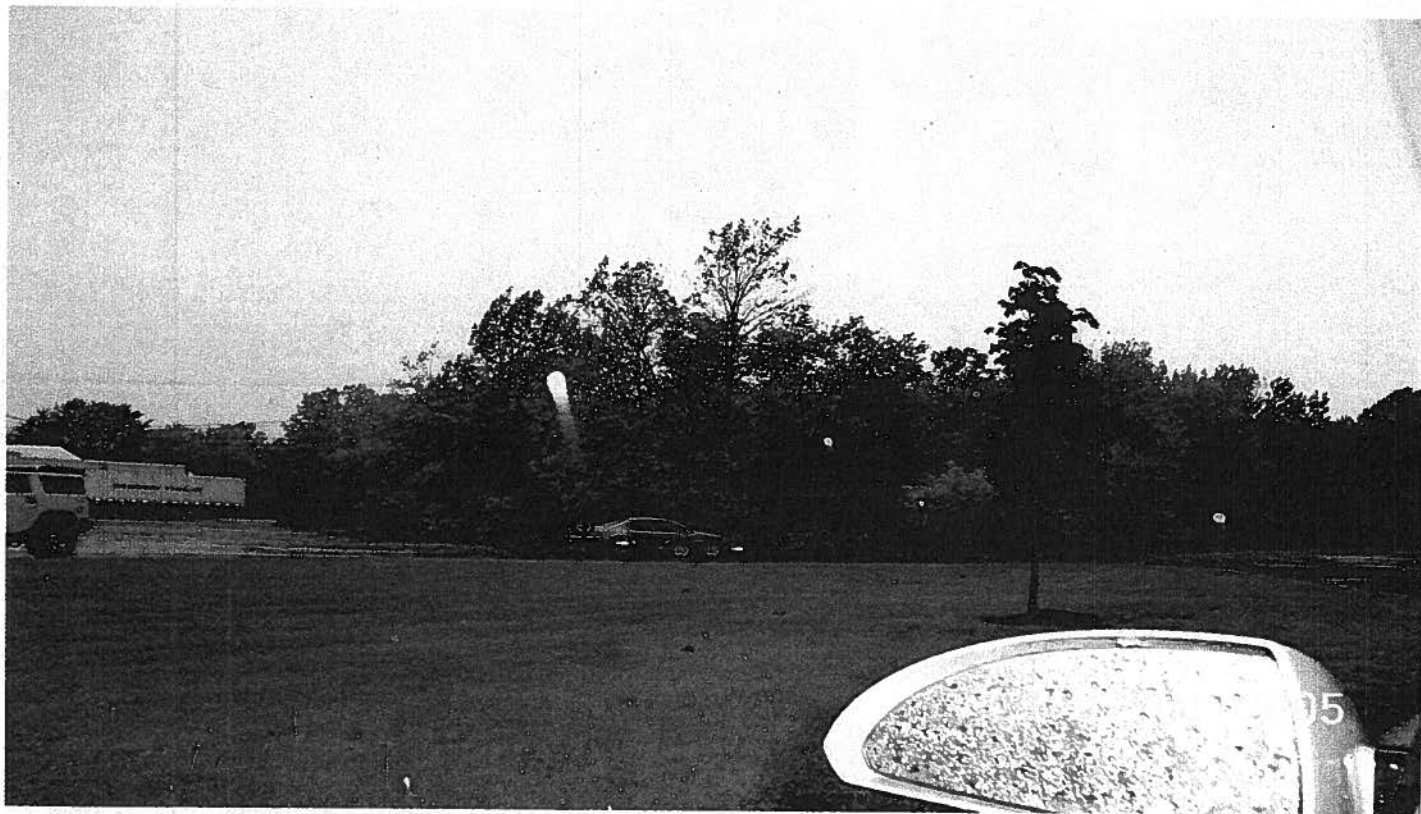
Taken from the First Assembly of God Church parking lot looking toward the rear of the used car dealer and Dunn Tire. The grassy area and wooded lot have yet to be surveyed.

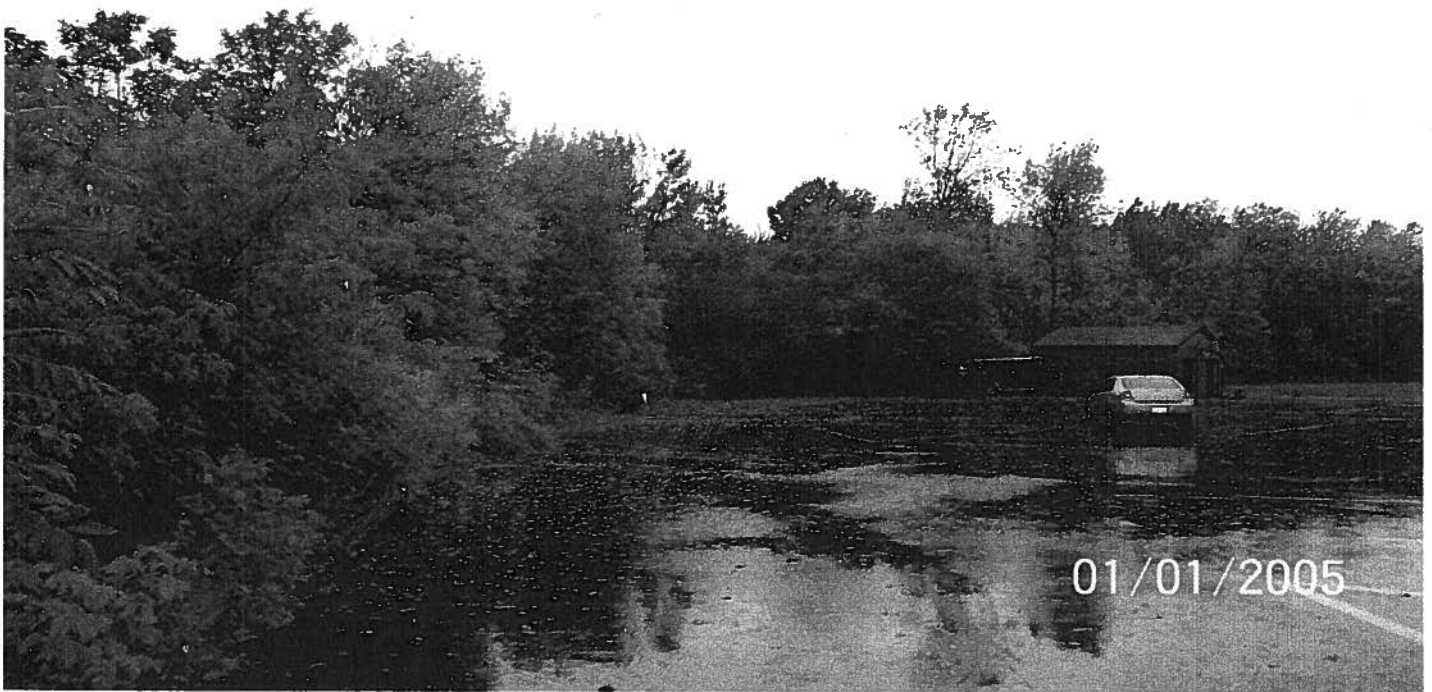
First Assembly of God Church parking lot. General area waist height readings to three times background were observed along the edge of the lot to the wooden structure in the background.

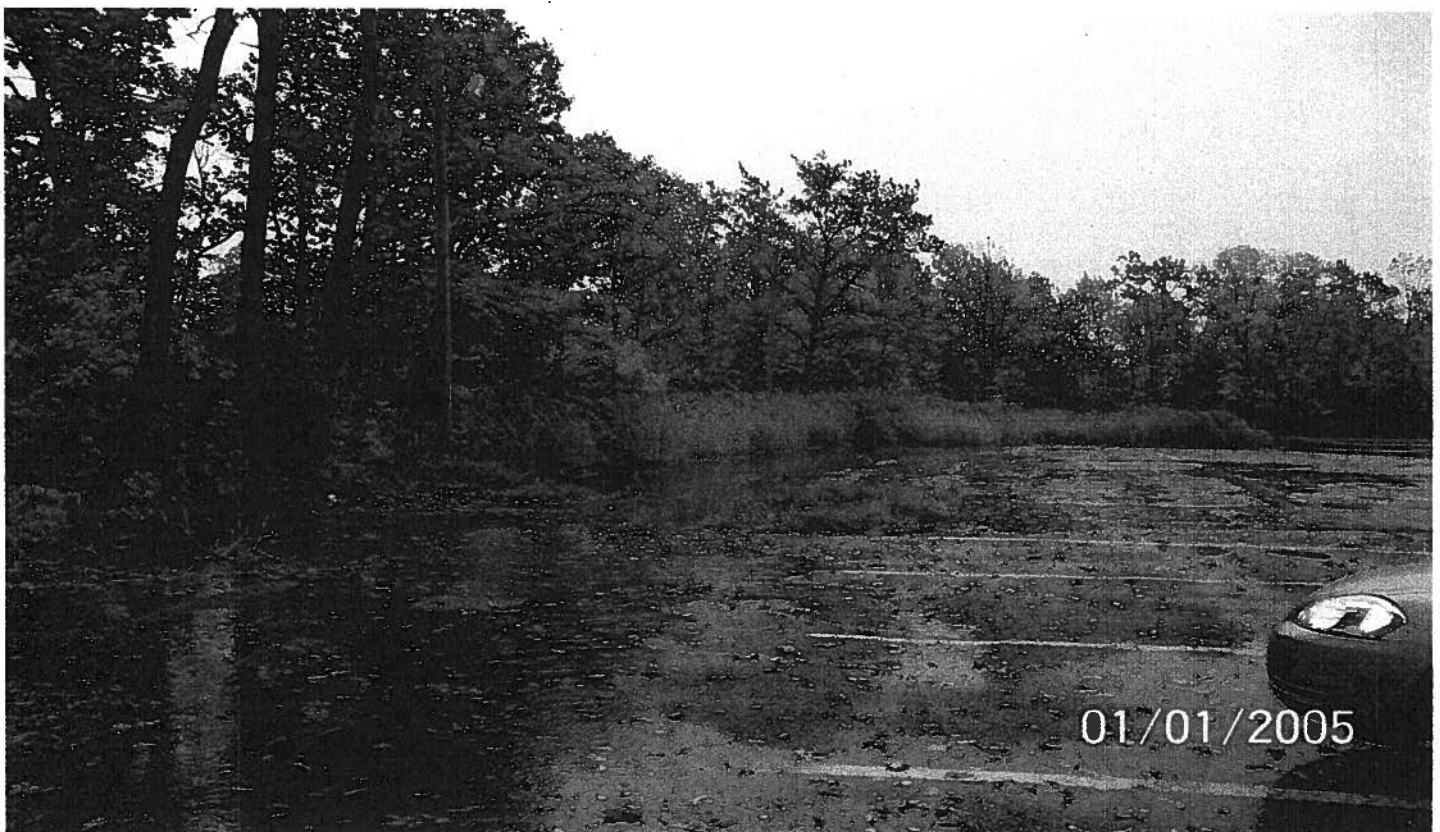
Photo illustrates just how wet the rear parking lot and marshy area that abuts it, really are. Within minutes of the rain commencing, the area was flooded. Hence the reason for the condition of the rear lot as seen in previous photos.
